# 19.5" UNIVERSAL MOUNT INDUSTRIAL MONITOR

## REVISION C

### PRODUCT RELIABILITY TEST REPORT

Report for: HIS-UM19.5-xxVC

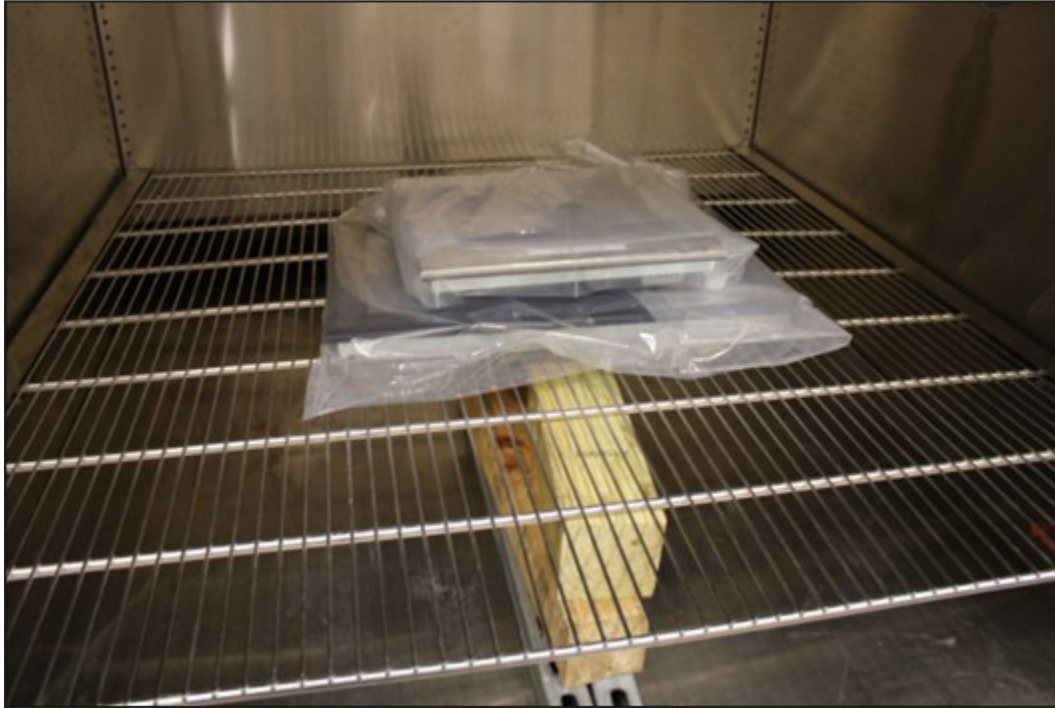
The photo below shows how specimens were installed in the chamber.

Specimen was found to be in good working order following the test.

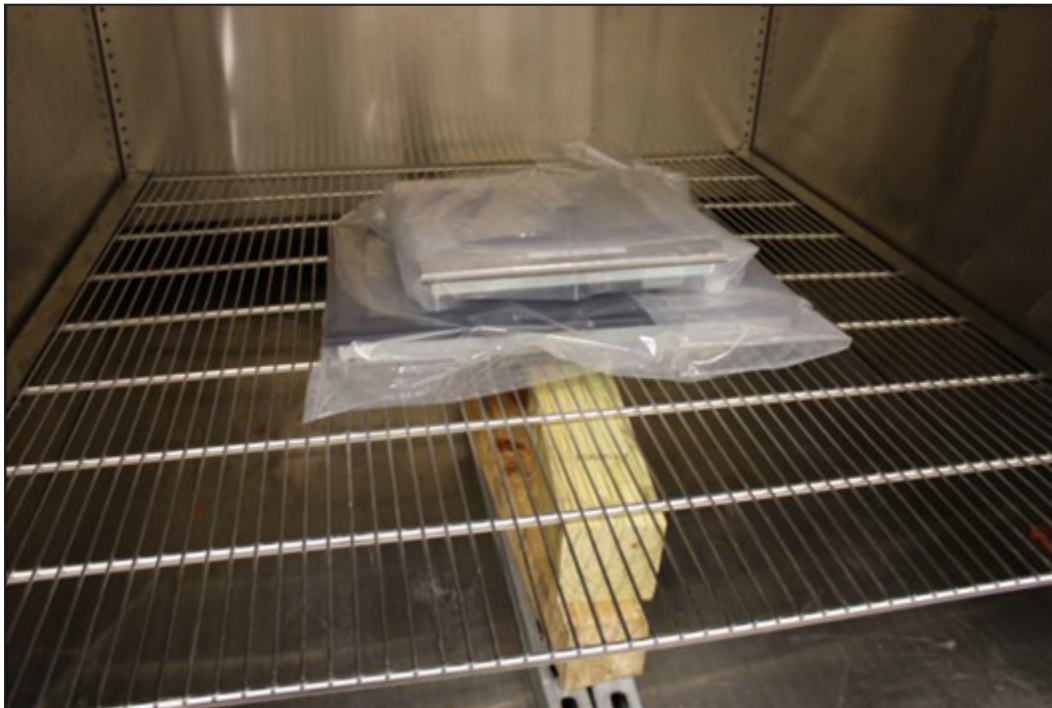
The photo below shows how specimens were installed in the chamber.

Specimen was found to be in good working order following the test.

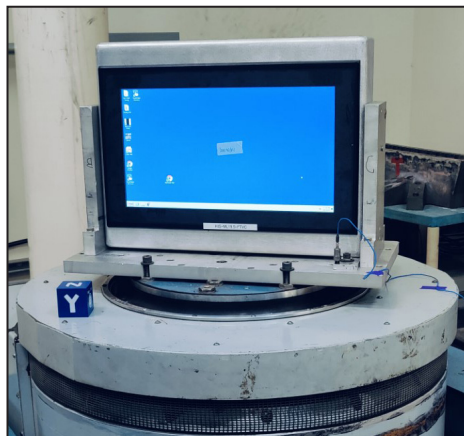
**Test Conditions:** 150 m/sec<sup>2</sup>, 6 msec half-sine pulses (nominal), 6 directions, 100 pulses per direction, specimen energized, specimen unpackaged

Below are pictures from the test.

Specimens were found to be in good working order following the test.

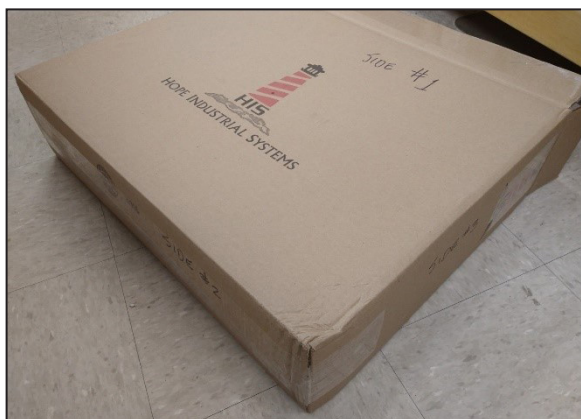
**Test Conditions:** 2 falls at each specified altitude, height based on mass, specimen not energized, specimen packaged, laboratory ambient

Below are pictures from the test.

Specimens were found to be in good working order and without any cosmetic defects at the end of the tests.

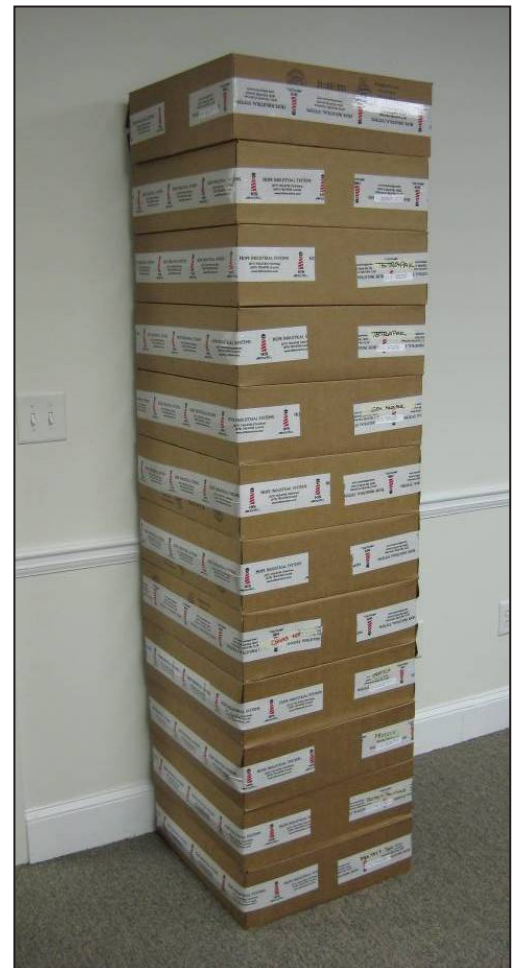
Pass – total dimensional change of the specimen was 3% of its pre-test dimensions.

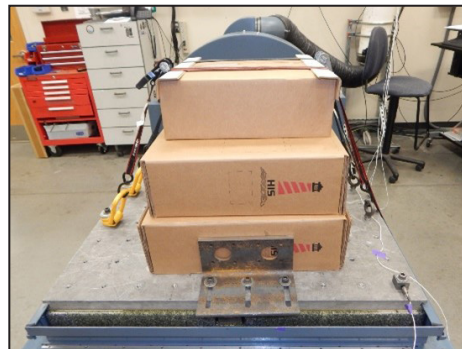
**Test Conditions:** ASD 1.0 from 10-100 Hz, -3 db/octave 100-200 Hz, then ASD 0.5, 200-2000 Hz, 3 axes, 30 min/axis, specimen not energized, specimen may be packaged

Below are pictures from the test.

Specimen was found to be in good working order following the test.

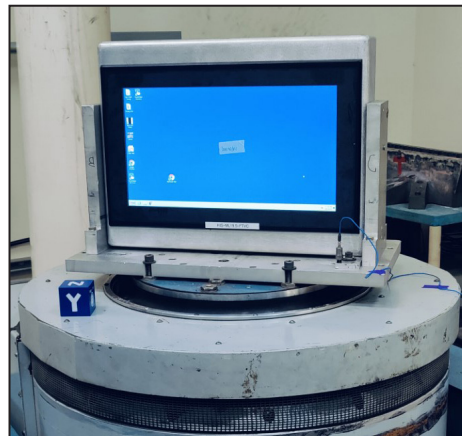
**Test Conditions:** 3.5 mm peak acceleration to 9 Hz, then 1 g (10 m/sec<sup>2</sup>) 9-500 Hz, 3 axes, 10 sweeps per axis at 1 octave/min, specimen energized

Below are pictures from the test.

Specimen was found to be in good working order following the test.
